Top12 – lowest life-cycle costs in high chloride-exposed reinforced infrastructures*

Measures to increase durability – Field experiments in the Naxberg tunnel in Switzerland*

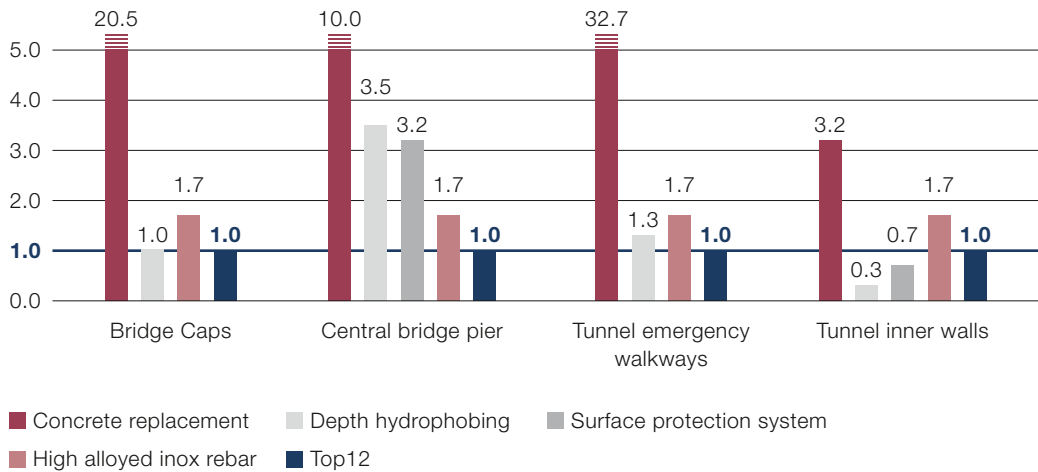
Results of life cycle costs*

Comparison of different variants (standardised to Top12) – vertical axis cut off at factor 5.0

- a) Conventional concrete replacement as a reactive repair strategy (carbon steel, no surface protection) results in the highest life cycle costs for all components!
- Top12 steel has significantly lower life cycle costs, especially with low reinforcement content.

- b) Comparison of Top12 with “carbon steel with surface protection measures”:
- For components with small concrete surfaces (pier), the variant with Top12 steel is more favourable.
 - For components with low reinforcement content (e.g. bridge caps, tunnel emergency walkways), the life cycle costs are roughly the same or the variant with Top12 is somewhat cheaper
 - For highly reinforced components with large concrete surfaces, e.g. tunnel inner walls, the variant with carbon steel and surface protection system is more cost-effective. Savings potential exists with Top12 in the use of mixed reinforcement (mix of carbon steel and Top12 with direct electrical contact).

- c) Comparison of Top12 with high alloyed inox rebar:
- Life cycle costs for Top12 approx. 40% lower

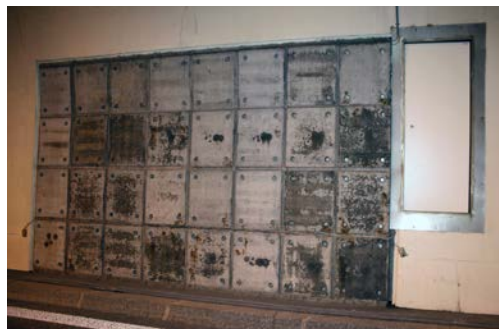
Test field in the Naxberg tunnel*

Since 2000, a field test with instrumented concrete slabs has been running for 12 years in the Naxberg tunnel on the A2 near Göschenen (CH). As part of the repair of the

tunnel, a unique test rig was set up, offering space for 32 test plates and enabling long-term investigation of damage processes and measures to improve durability (initiation and corrosion phase) under real conditions.

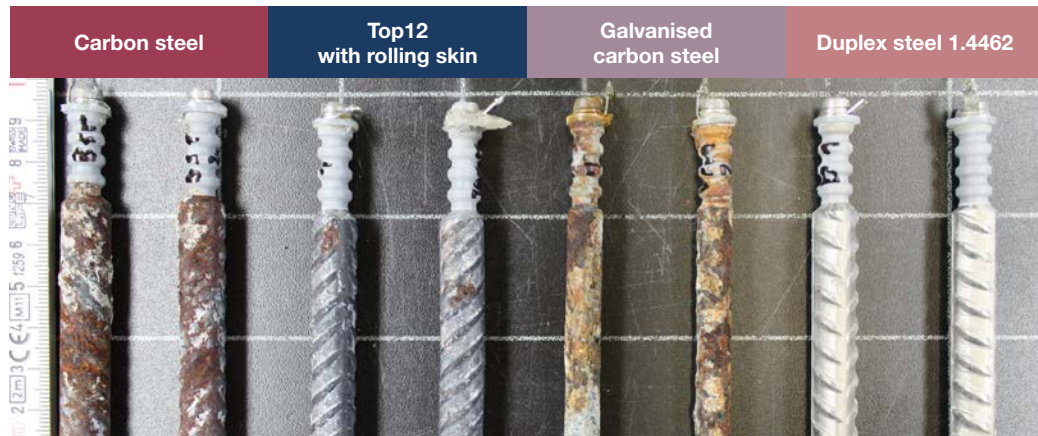
Results after 12 years in alpine tunnel exposition (concrete cover = 10mm)*

- Carbon steel and galvanised steel showed pitting corrosion and a corroded steel surface of more than 70%
- The zinc coating is practically completely dissolved and the steel underneath corrodes under pitting appearance. The zinc coating corrodes in moist and chloride-containing concrete at high speed, so that the protective effect of the zinc is quickly exhausted and represent no added value.
- The stainless steel “Top12” has only a few small rust spots without measurable material loss
- Stainless duplex steel 1.4462 is absolutely bright and still passive, as expected
